UBD - Live well drilling and completion

4½" UBD Liner installation

Rig-less abandonment

Gas storage well operation

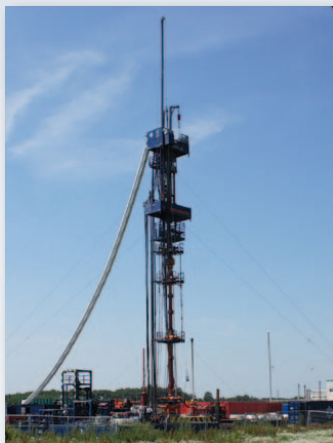
- HWO/Snubbing unit was required in order to deal with pressurized well conditions.
- 21m high BOP stack was assembled to lubricate BHA's in- and out of the well.
- Well deepening was conducted utilizing a MWD assembly with a 5 7/8" PDC bit powered by a 4 3/4" GT Motor. The HWO unit rotary table provided additional rotating performance.
- 4½" Liner needed to be deployed under pressure.

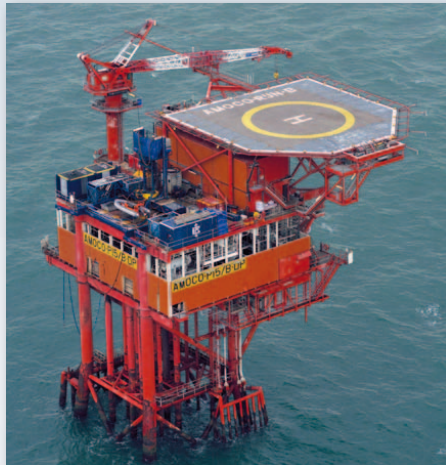
- HWU was required in order to deal with the extreme small space present on the platform and the limited load bearing capacity of the platform.
- The cut was made utilizing a mechanical tubing conveyed rotating cutting device.
- Hydraulic cylinders were used to apply pre-tension on the conductor while cutting.
- The 3 casings were retrieved in one lift utilizing the same crane vessel as used to remove the platform.

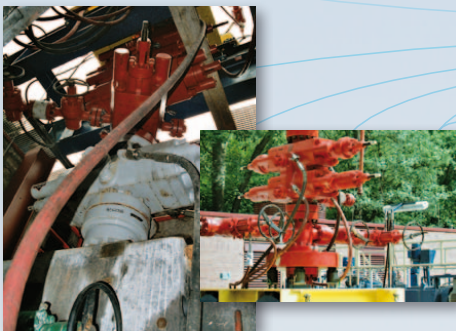
A down-hole explosion occurred during regular maintenance, which caused the well to blow out.

This explosion caused major damage to the completion, casing and well-head.

- BPC coordinated the entire project.
- The completion was found shattered in pieces, but access to the required depth was achieved.
- Well-head was changed out and the well was secured.

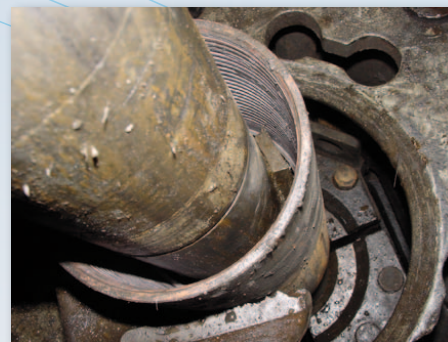
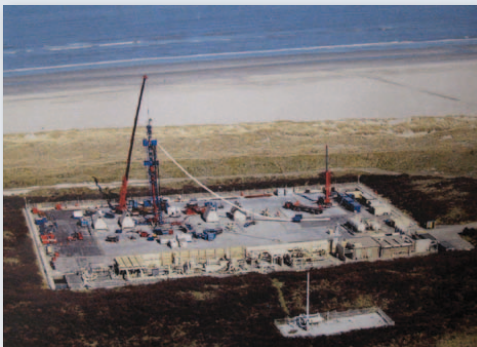
- HWO/Snubbing unit was required in order to deal with pressurized well conditions.
- 22m high BOP stack was assembled to deal with all challenges present on the live well.
- Straddle pipes and packers were stripped to surface under pressure.
- New CR13 completion was installed without surface pressure.

- Successfully retrieved the 600m long straddle.
- Formation was saved and well was brought into full production.
- Zero incidents and accidents.
- Technical challenges were successfully achieved.
